BRICK CLADDING PROBLEMS

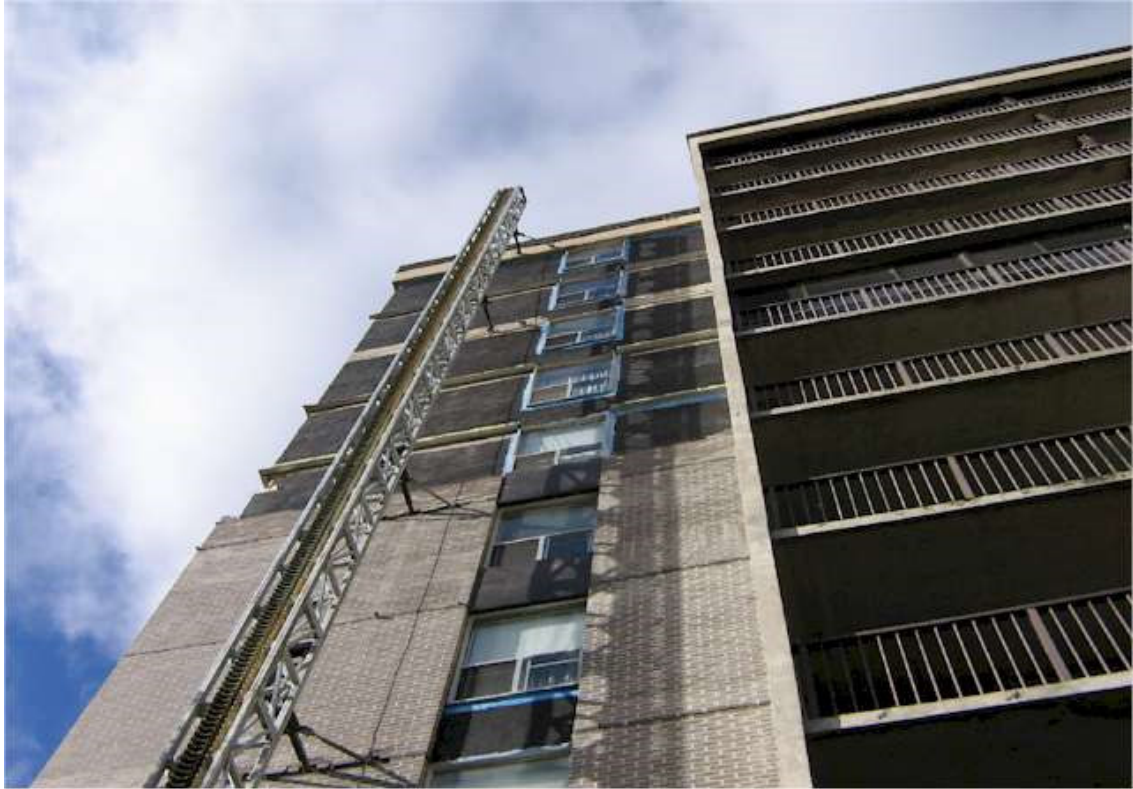
The investigation concluded that the steel shelf angles which were located at each floor slab, exhibited widespread and severe corrosion on the seven (7) upper floors.

The project involved the complete removal and replacement of the brick veneer and steel shelf angles on the east elevation, and associated envelope component upgrade.
