PARKING GARAGE REHABILITATION

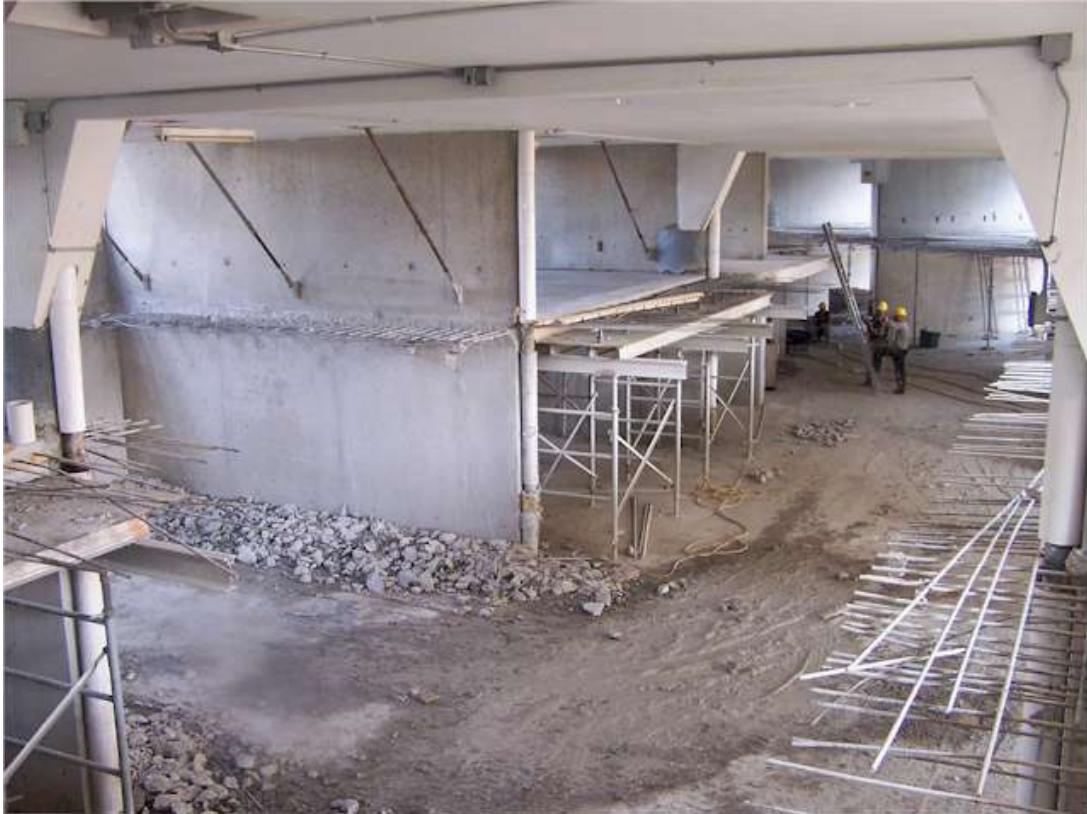
In 2004, Concentric was retained to investigate through-slab leakage and general deterioration of a two-level cast in place parking structure serving a high rise condominium.

The investigation, which included concrete coring and laboratory analysis, concluded that the leaking slab cracks had caused moderate to severe section loss in the reinforcing steel and had lead to extensive soffit delamination.

Concentric designed and tendered the repair program, which included complete slab replacement over a significant area of the intermediate suspended slab.

The project was implemented in 2005 and was successfully completed on time and on budget.
