WASTE WATER TREATMENT PLANT ROOF PROBLEMS

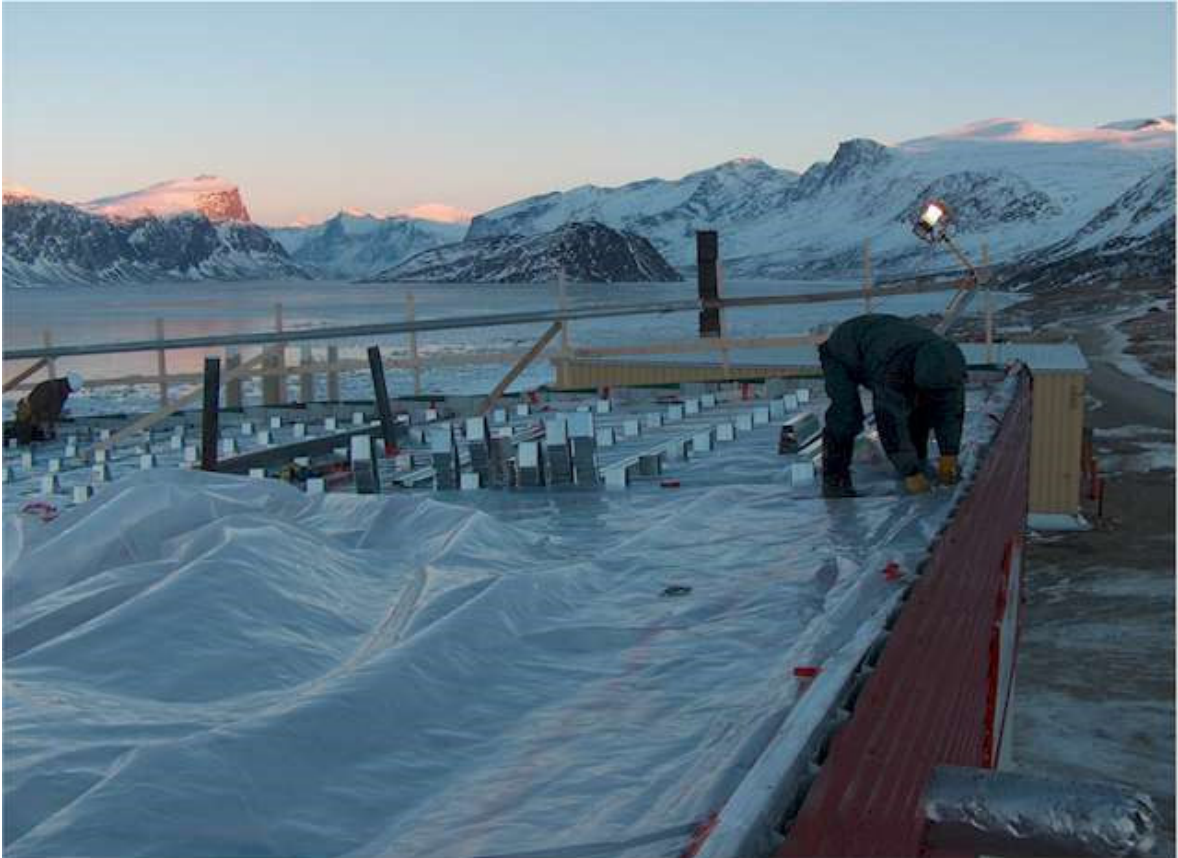
In the late summer of 2005 Concentric was retained to assess and investigate extensive wind damage to the roof and exterior walls of this modern wastewater treatment plant.

The assessment and subsequent investigation and analysis concluded that the roof assembly was not structurally adequate to resist the local wind pressures and gust effects.

Because the facility had to remain in operation during the repairs, the repair program had to be as non-intrusive as possible.

Concentric developed a workable solution that was able to re-use the existing steel deck and therefore required minimal disruption to plant operations.

All new materials had to be airlifted in, which required a significant logistical effort and no margin for error in the design.
